Minerals Inspection Report

Mine Name: 2 More Feet	Permit Number: S/013/0007	Mine Status: Inactive
Operator Name: Scott Higley	Inspection Date: 06/25/2013	Permit Fees: Delinquent
Inspector(s): L. Heppler	Inspection Time: 4:48 PM	Bond Amount: \$3,000
Attendee(s): Dave Herron USFS	Weather: Sunny, Dry	Bond Escalation: 07/14/2009
Inspection Purpose: Routine annual inspection		Prior Inspection: 09/20/2010

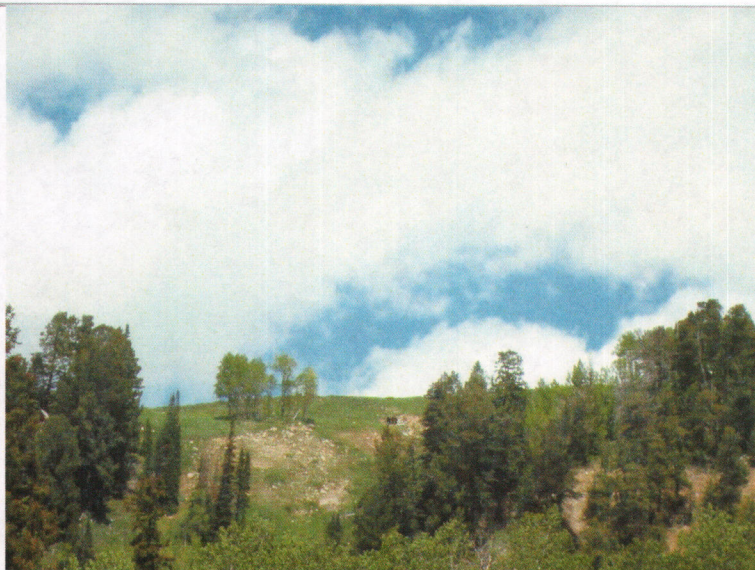
Shaft covering in the distance

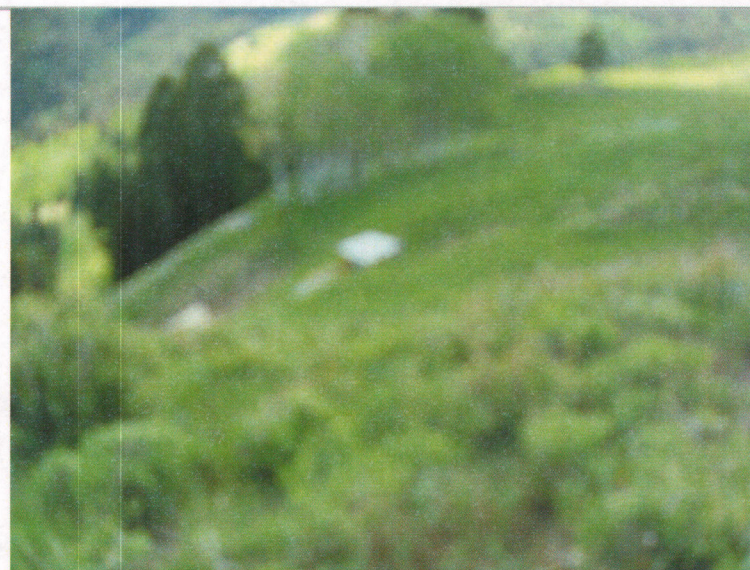
Hiking down to shaft

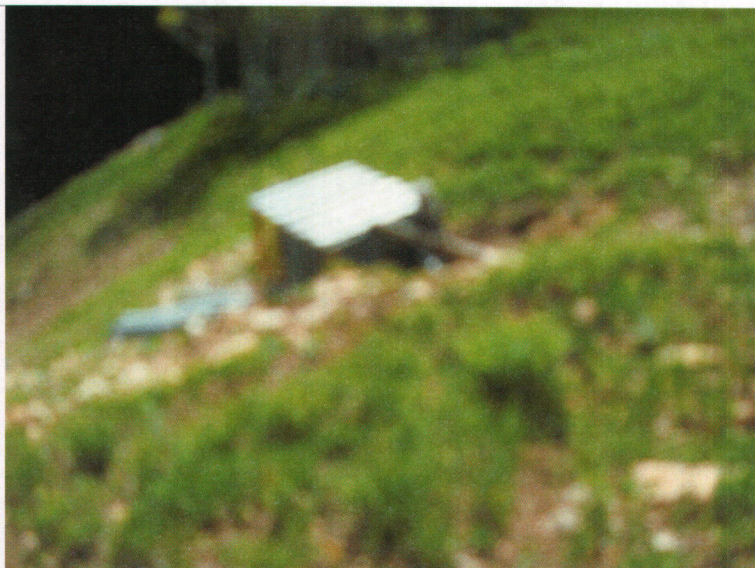
Operator needs to pay past due permit fees and update the annual reports. OGM to continue annual inspections and monitor the site when in the area. No new work has been done to this site since the last inspection. This is a small disturbance, but nonetheless a visible disturbance for the area. A bond escalation letter was sent out on June 22, 2009.

Close-up of disturbance

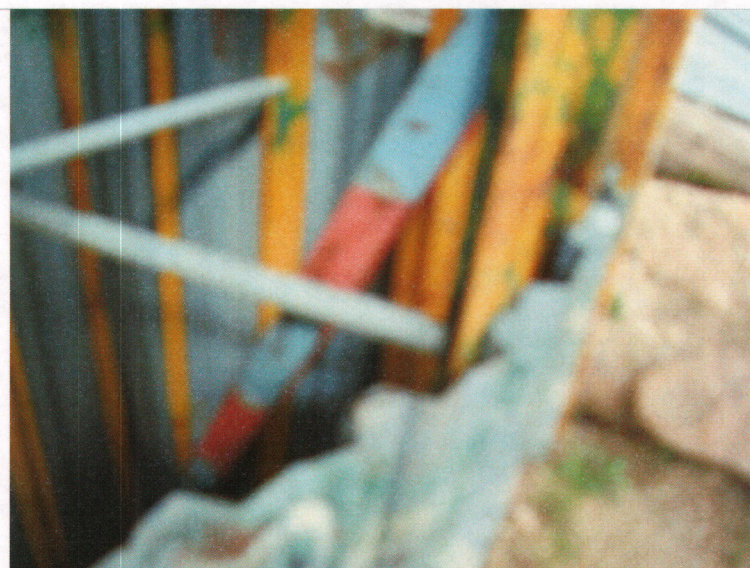
2. <i>Public Safety (shafts, adits, trash, signs, highwalls)</i> Shaft can be accessed by anyone, but depth is less than 10 feet.	<input checked="" type="checkbox"/>	<input type="checkbox"/>

Looking into the shaft
